## **Cuyahoga River Bulkhead Technical Assistance Cleveland, OH**

Conceptual Designs and Cost Estimates  
for Bulkhead Repair and Slope Stability Improvements  
in the Vicinity of Riverbed Street

**August 2009**

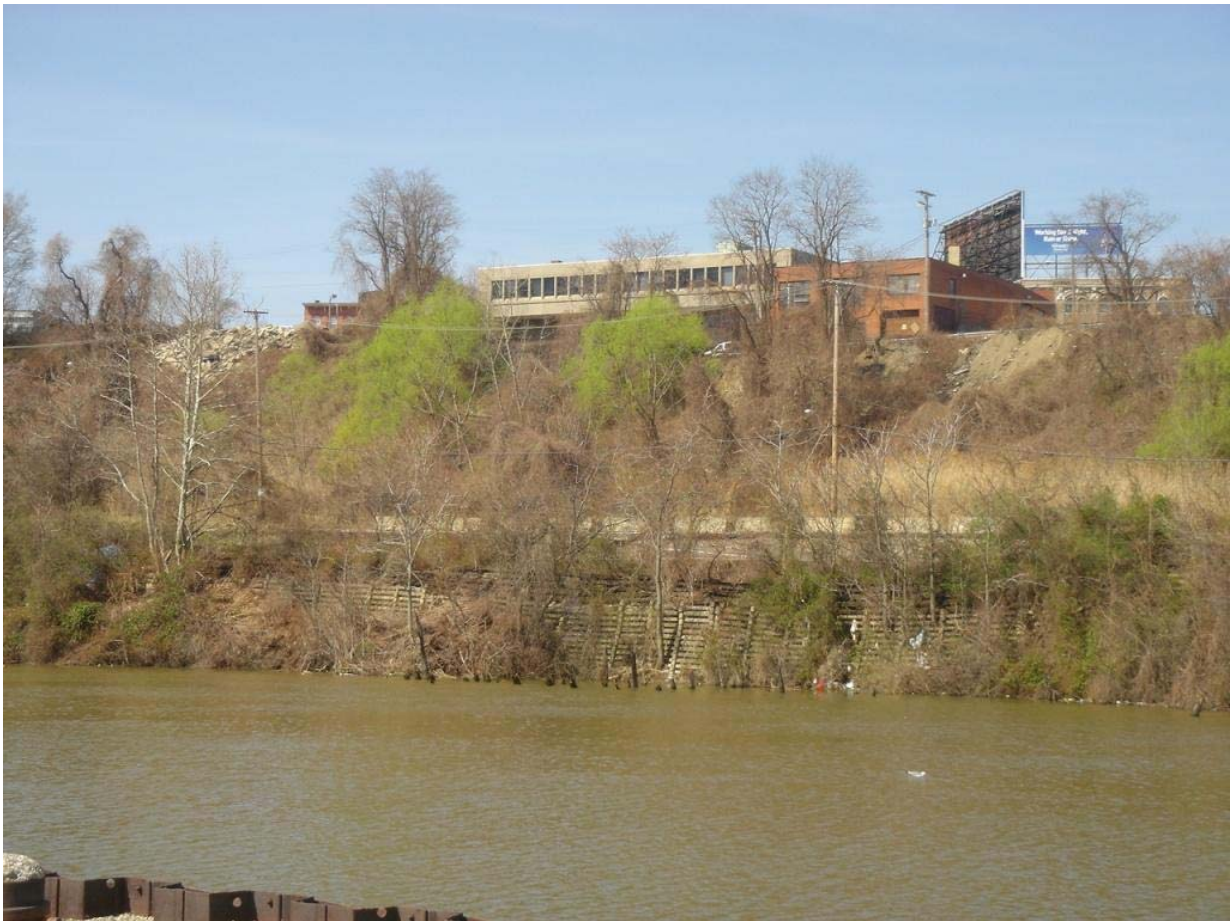
Image 6.1.1: Existing Cribwall. Source: USACE Field Inspection, 17 Apr 2008

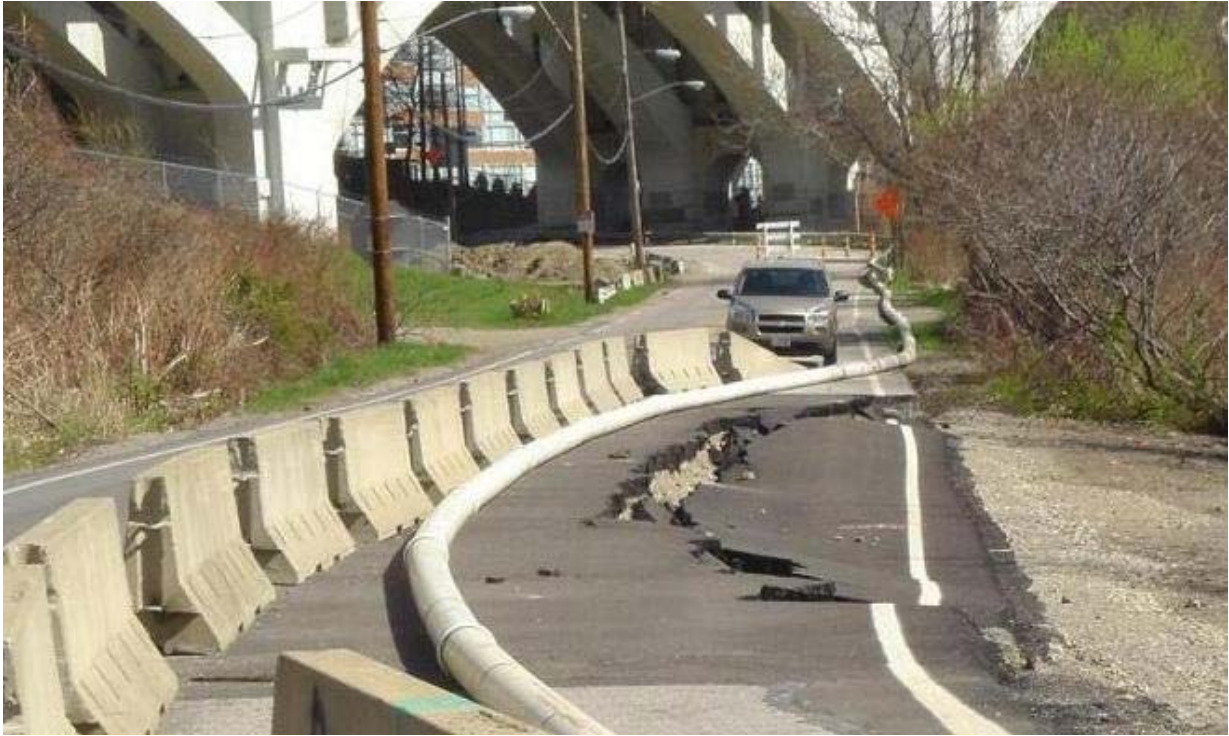
Image 6.1.2.: Riverbed St., Downstream Failure. Source: USACE Field Inspection, 19 Apr 2006

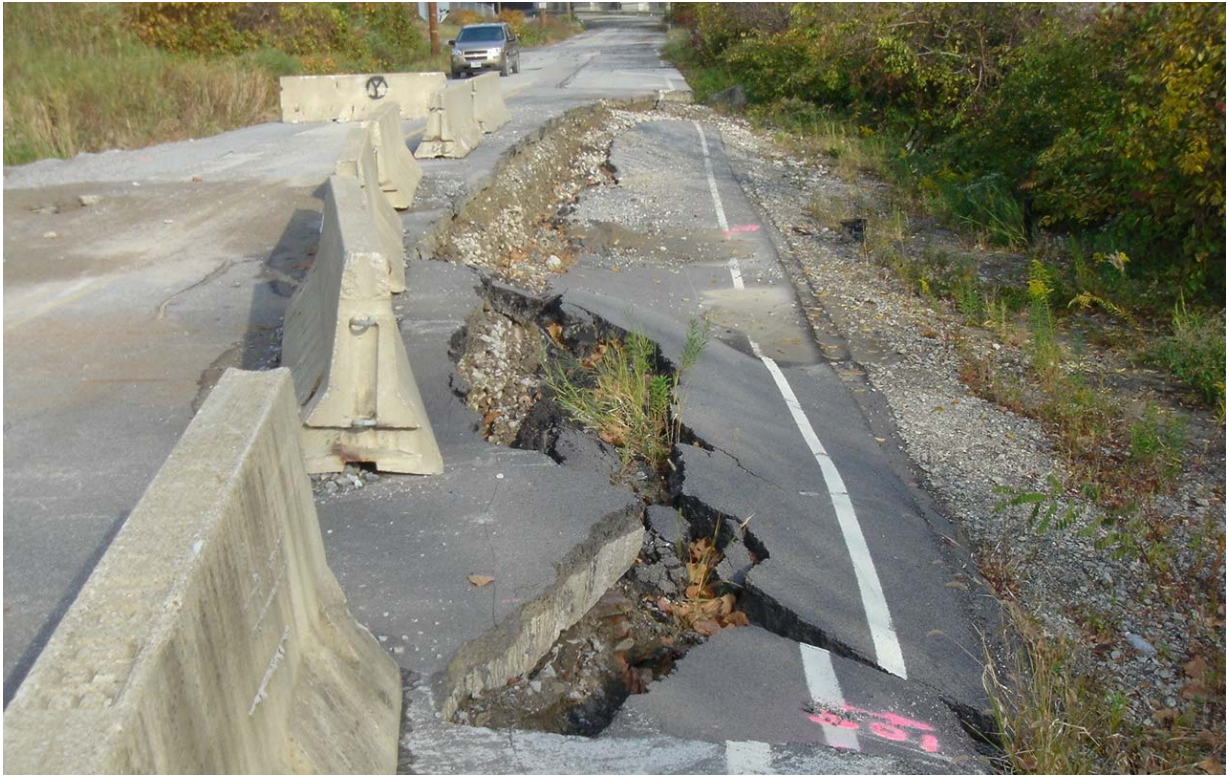
Image 6.1.3: Riverbed St., Downstream Failure. Source: USACE Field Inspection, 19 Nov 2007

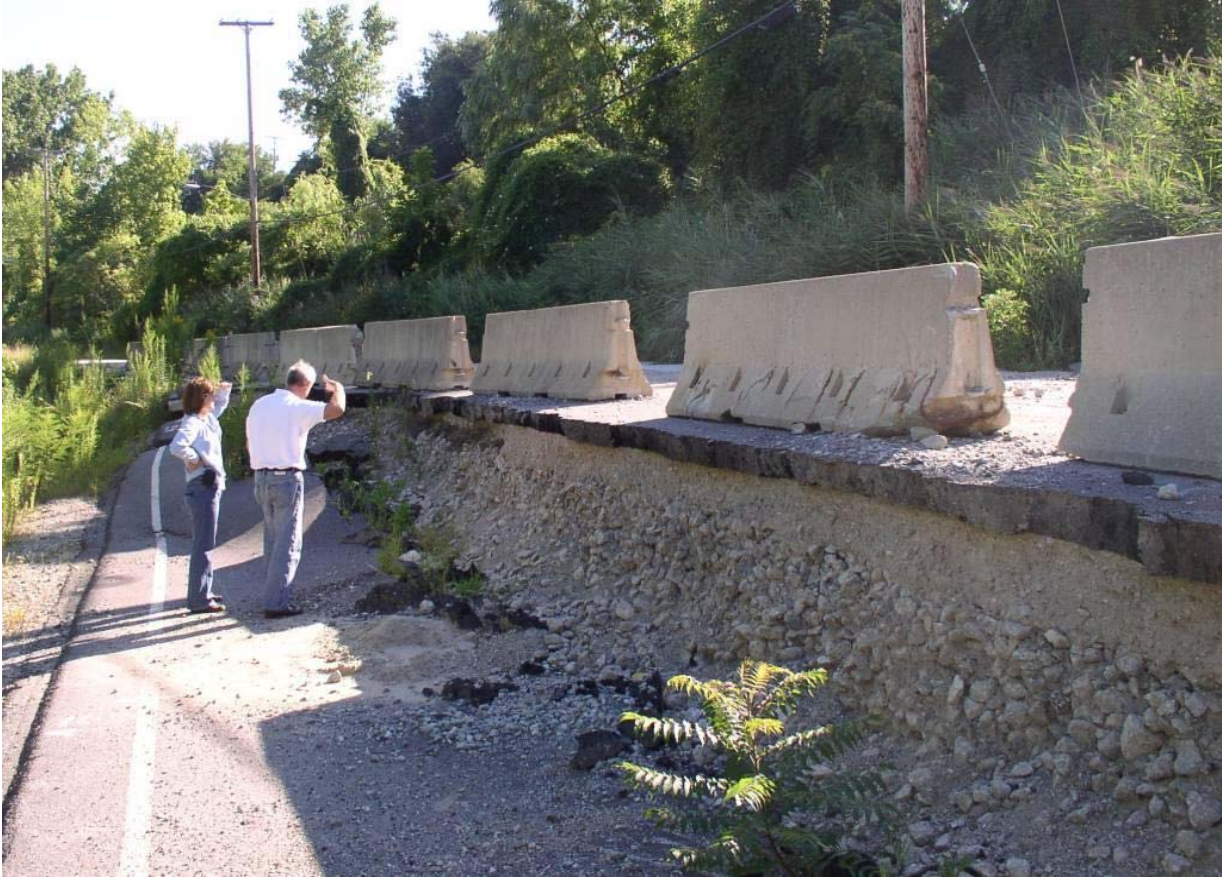
Image 6.1.4: Riverbed St., Downstream Failure. Source: USACE Field Inspection, 20 Aug 2008

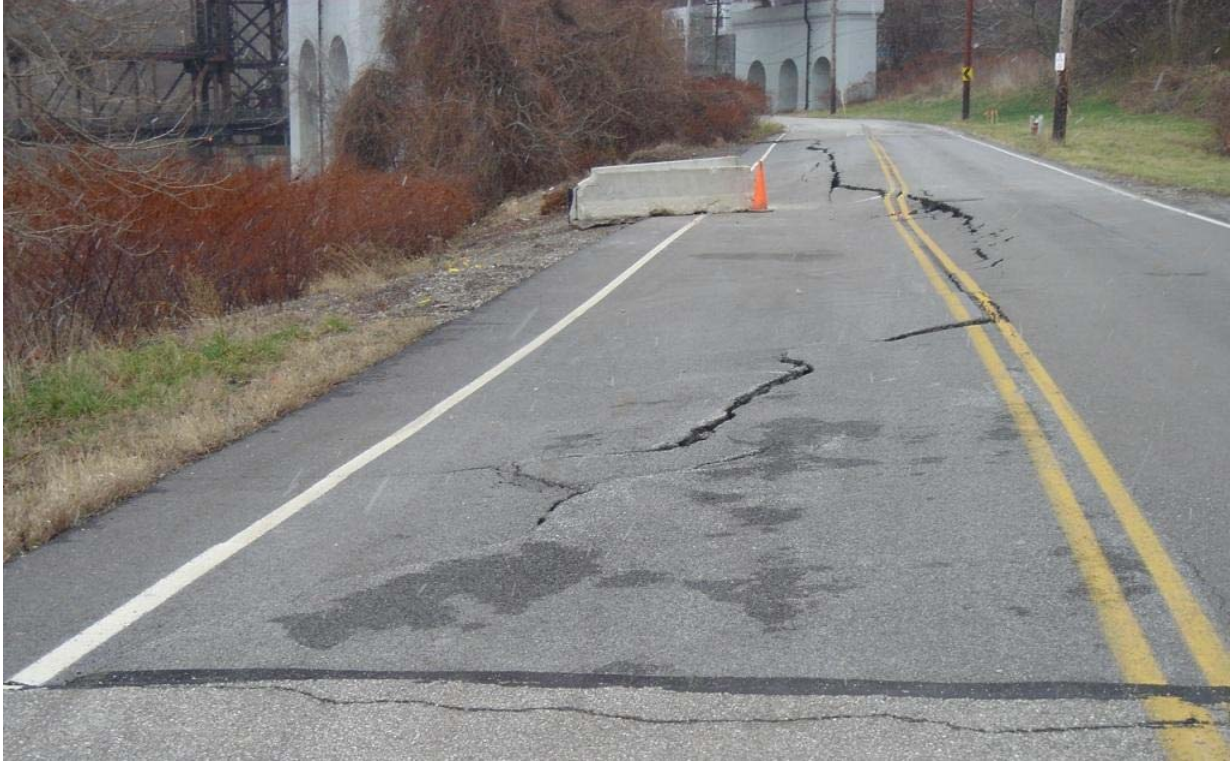
Image 6.1.5: Riverbed St., Upstream Failure. Source: USACE Field Inspection, 8 Jan 2007

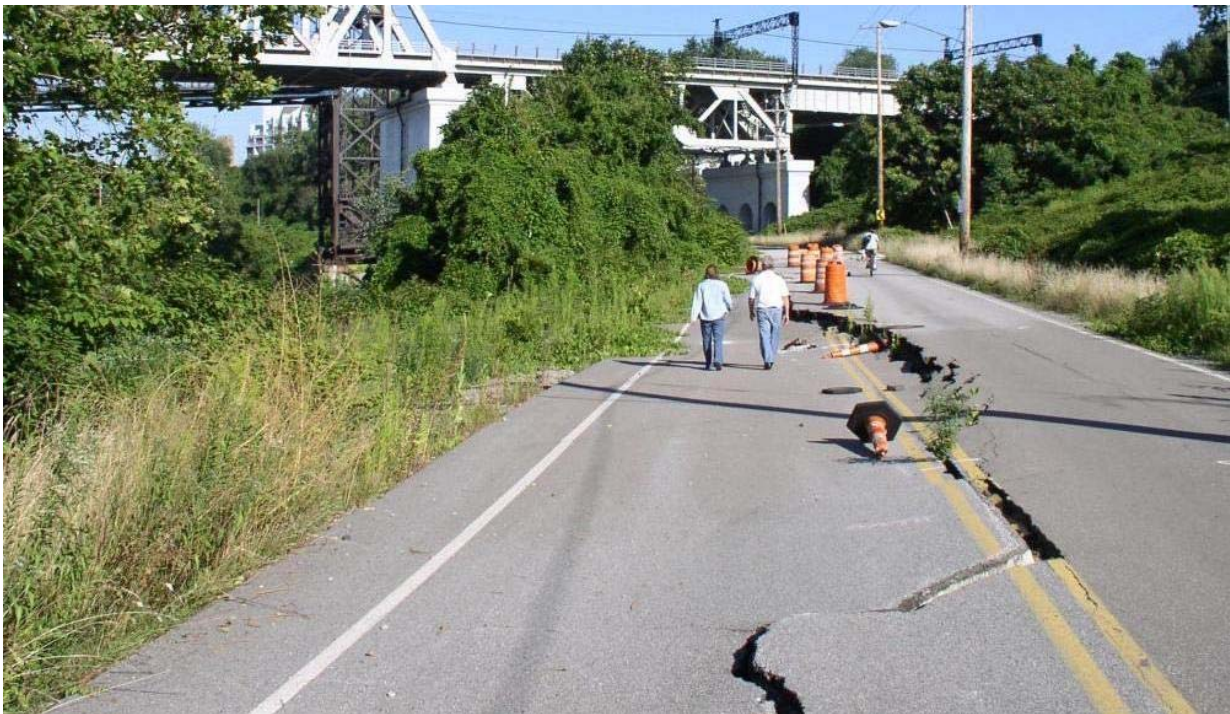
Image 6.1.6: Riverbed Street, Upstream Failure. Source: USACE Field Inspection, 20 Aug 2008

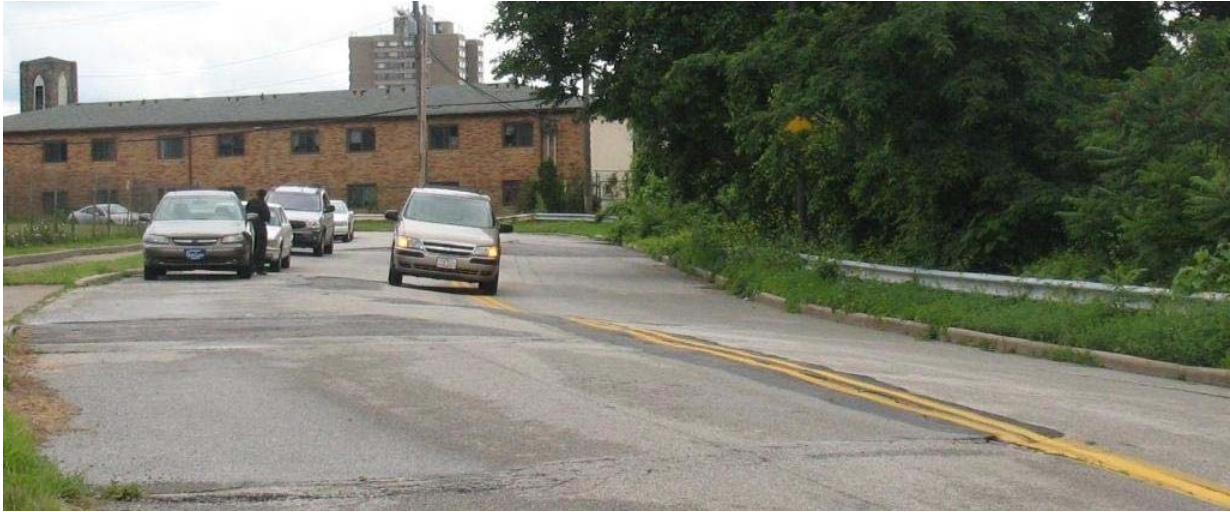
Image 6.1.7: Upper Slope Scarp Failure along Franklin Ave.  
Source: USACE Field Inspection, 30 Jun 2008

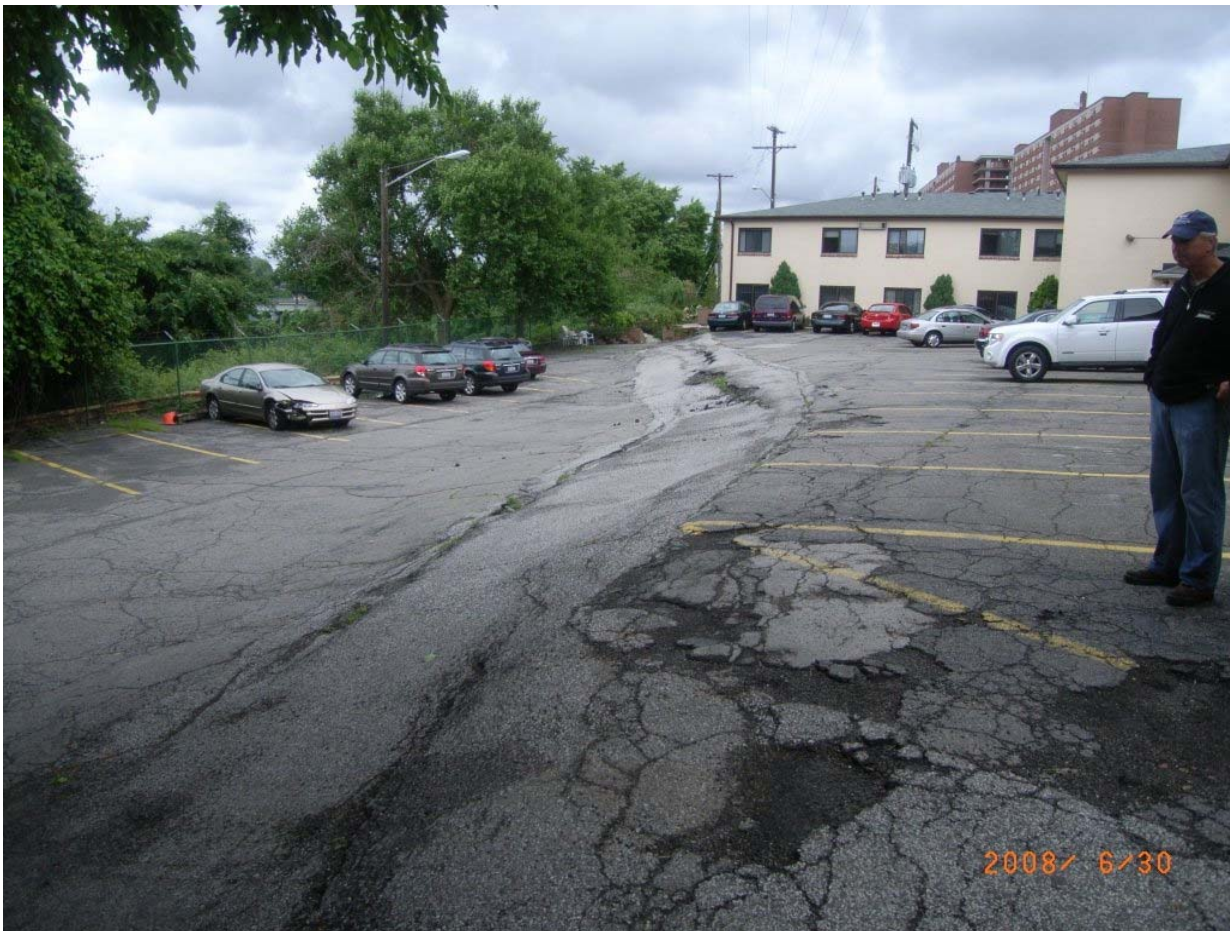
Image 6.1.8: Upper Slope Scarp Failure in parking lot along West 25<sup>th</sup> Street.  
Source: USACE Field Inspection, 30 Jun 2008

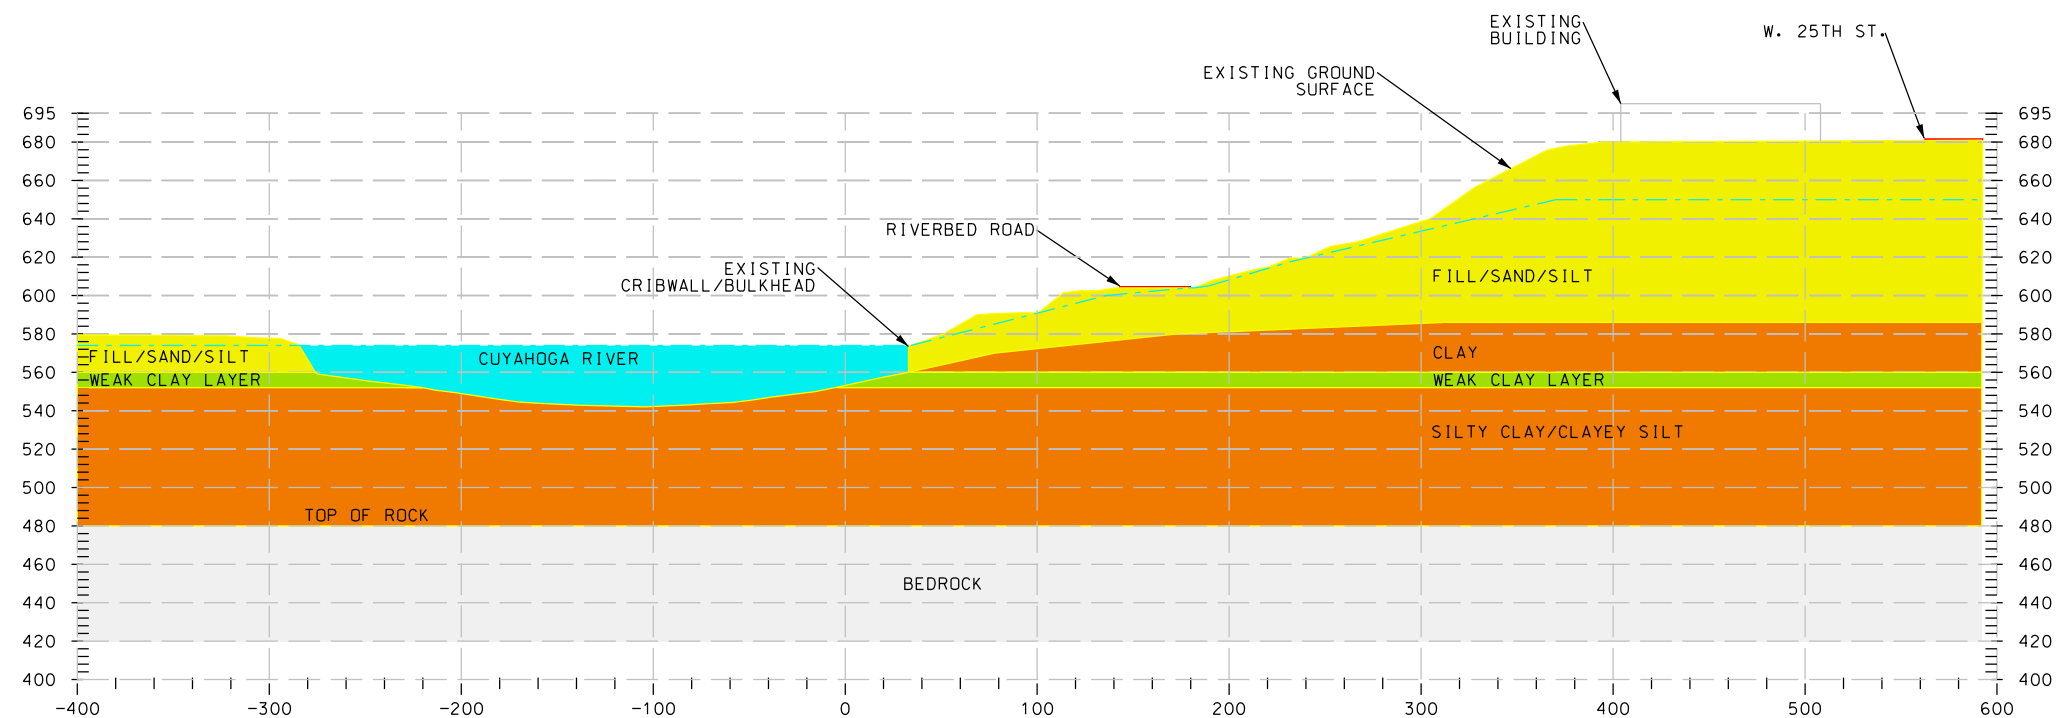
CROSS-SECTION FOR  
 EXISTING CONDITIONS  
 NO ACTION ALTERNATIVE

The existing site condition consists of a heavily vegetated slope which overlies the partially failed Riverbed Street and a partially failed bulkhead on the Cuyahoga

River bank. A major sewer line which runs along Riverbed Street has shown signs of distress in recent years. At various locations at the top of the slope (near West 25th Street) and mid-slope along Franklin Avenue, scarps ranging in height from a few inches to several feet exist. The overall slope has been creeping downward slowly. The localized failures at the bottom of the slope occurred suddenly, the result of a lack of support at the toe of the slope.
