Understanding

Irish Town Bend

Prepared by Citizens Vision
www.citizensvision.org
info@citizensvision.org

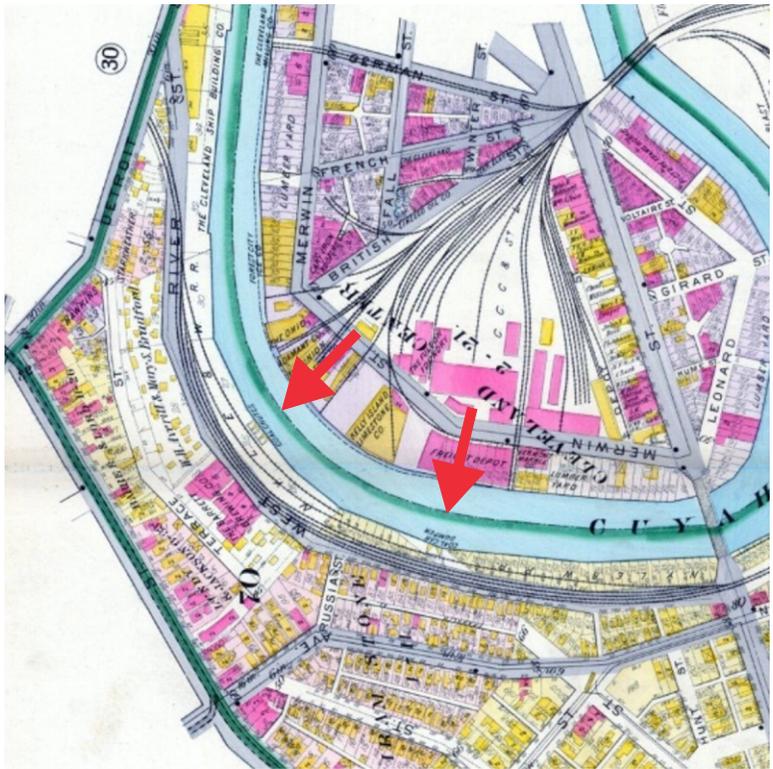
Irishtown Bend in 1898.
Note the two coal dumper locations

There were trestles where hopper cars unloaded coal into two bunkers for transfer to ships (See maps). Rail traffic became so great that at one time there were eight tracks, including the two coal trestles, curving around the Bend between Riverbed Street and the river’s edge.

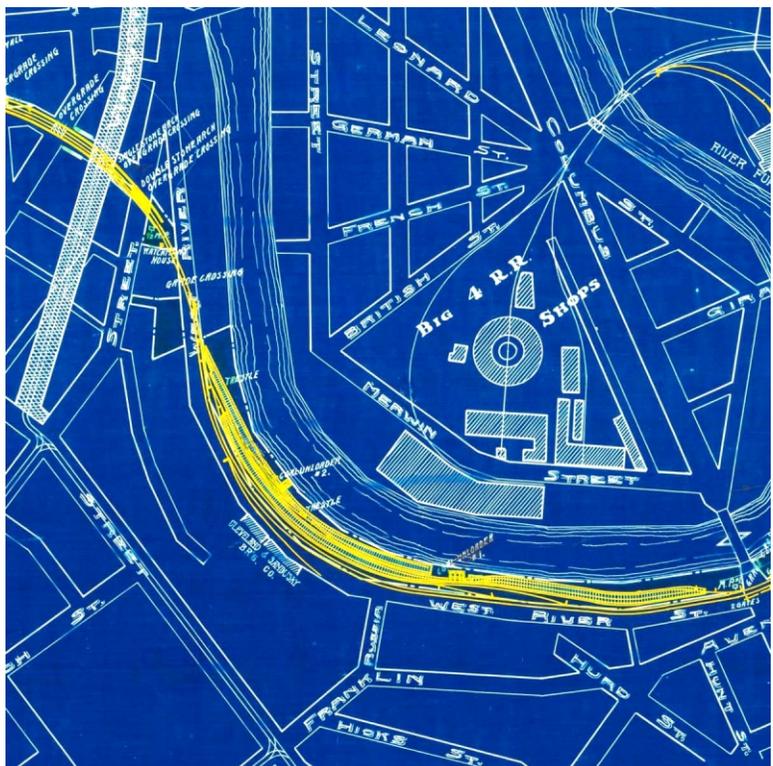
Erie Railroad through Irishtown Bend, 1904.
The coal trestles are clearly seen, along with the two dumper locations.

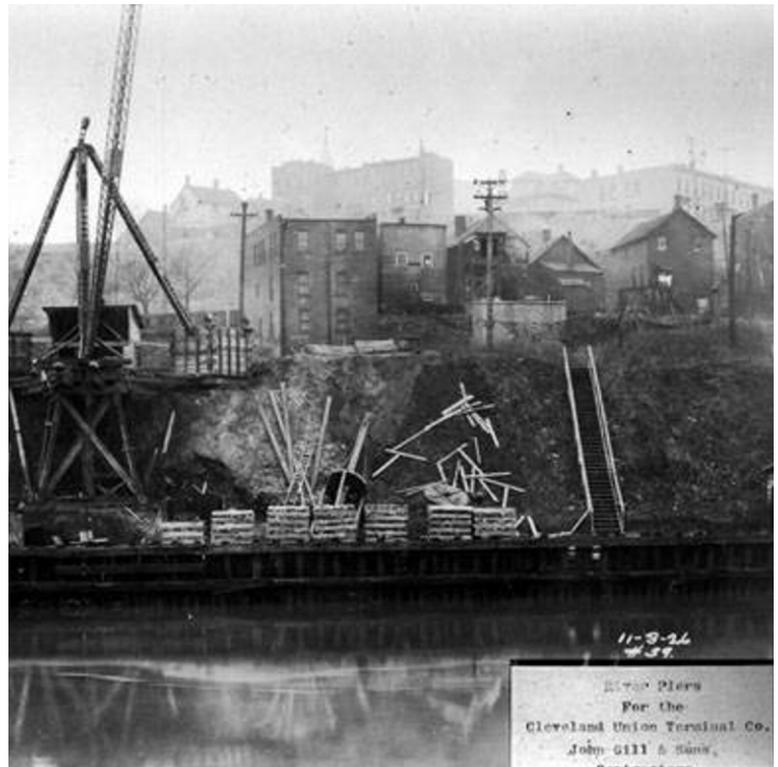
Building the supports for the coal trestles—wooden cribs filled with stones.

Building the trestles for coal unloading

The base for the trestles was land that had been graded flat. Wooden cribs filled with stone were erected to support the trestles, except for the two locations for coal to drop through the trestle into the bunkers. Cribs, rather than posts or pilings, were probably used to spread the load out over the soft soil of the Bend.

Over time, the coal trestles were no longer used, and the trestles were torn down, but the cribs were left behind and are still visible today.

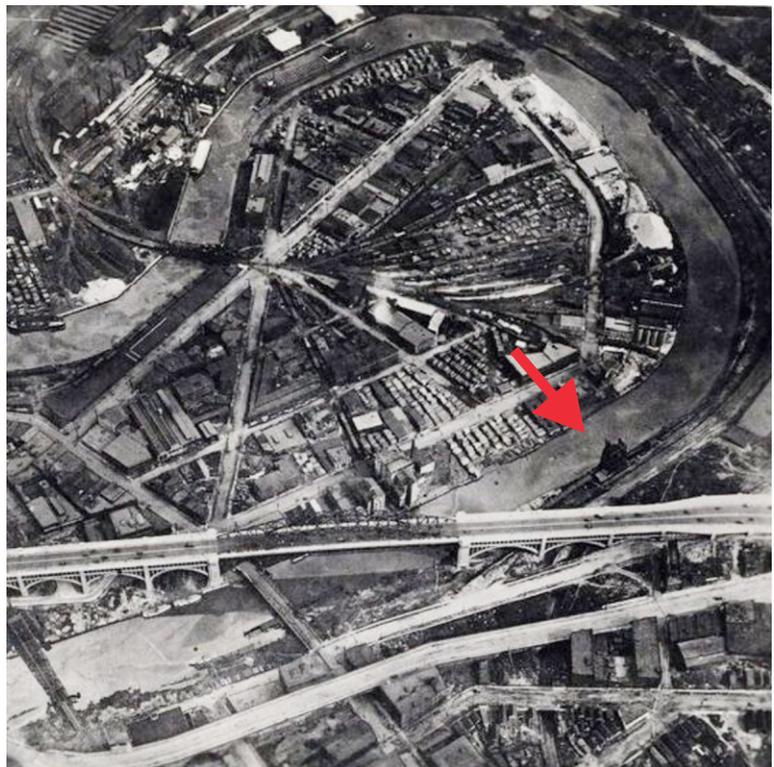
A view of the Bend some time between 1918 and 1940. The Wellman car dumper is just south of Veterans Memorial bridge.

The date of “a view of the Bend” photograph could not be found, but in the picture is the Veterans Memorial Bridge, finished in 1918, and the old double swing bridge on Columbus Road. That bridge was replaced by a lift bridge built by the WPA in 1940. Also the Wellman car dumper is there (The date of its removal is unknown) Therefore the date of this picture is some time between 1918 and 1940.

This picture also shows the industries on the east side of the river, between Merwin street and the river bank, which were later removed so that the channel could be widened.

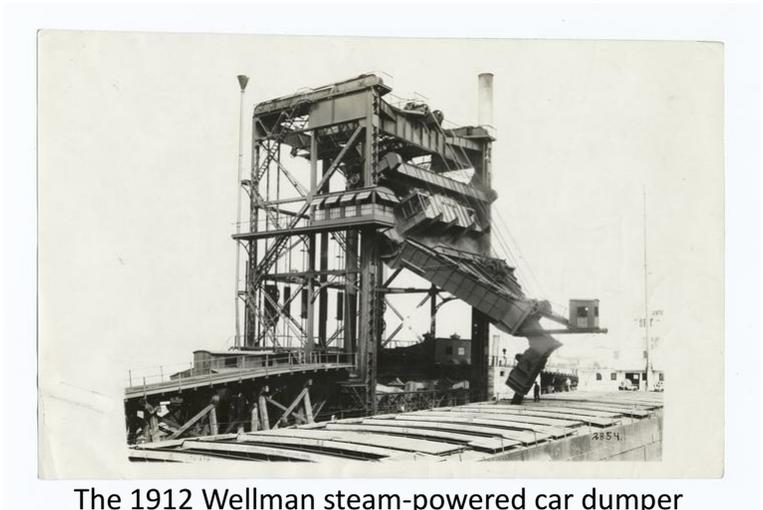
The Wellman steam-powered car dumper was invented by George Hulett, who also invented the Hulett iron-ore unloaders. As were the Hulett unloaders, the dumper was built by the Wellman-Seaver-Morgan Company of Cleveland. It lifted the rail car high in the tower and flipped it over, dumping its contents into a funnel-shaped chute that loaded one hatch of a ship. Notice the operator's cab on the end of the chute.

The 1912 Wellman steam-powered car dumper

In 1912, the railroad erected a Wellman car dumper just south of the Veterans Memorial bridge. That dumper was torn down some time before 1951.

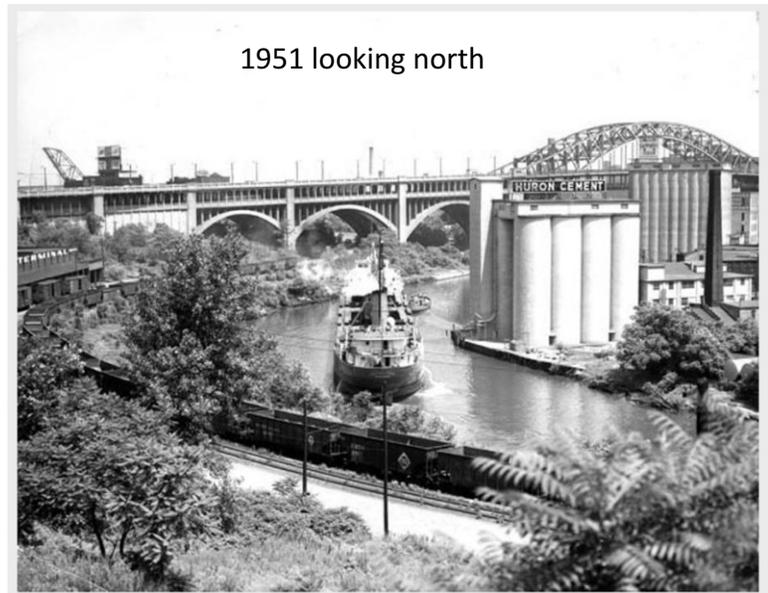
1951 looking north

In 1951, the Huron Cement Company still occupied the east bank. It was torn down a few years later to make way for widening of the channel.

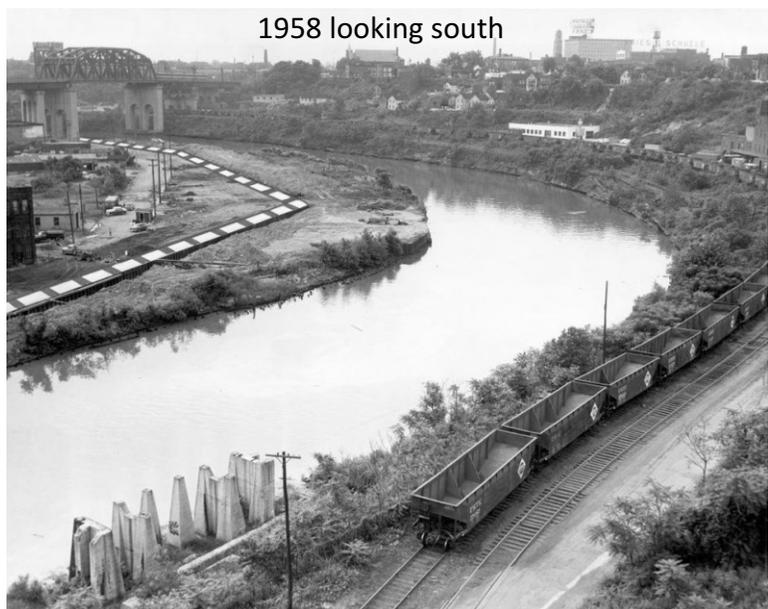
1958 looking south

In 1958 we see the preparations for the widening of the channel. The Huron Cement silos are gone, and other buildings between Merwin Street and the river had been razed. Next to the dotted line, sheet piling has been driven to delineate the new east bank of the river.

You can see a few houses still standing on Terrace Street (which was subsequently torn up), although reportedly they were vacant and soon to be razed. A few industrial buildings are there as well. Some were torn down between 1955 and 1958. The long, white building was the home of Warwick Products, a fabricator of specialty equipment cases and other high quality laminated wood products. Later, Warwick and the other businesses were forced to vacate, as the hillside was found to be slowly sliding toward the river.

Two railroad tracks were still in use in 1958, but coal trestles are gone. The concrete piers next to the river had supported the Wellman car dumper.

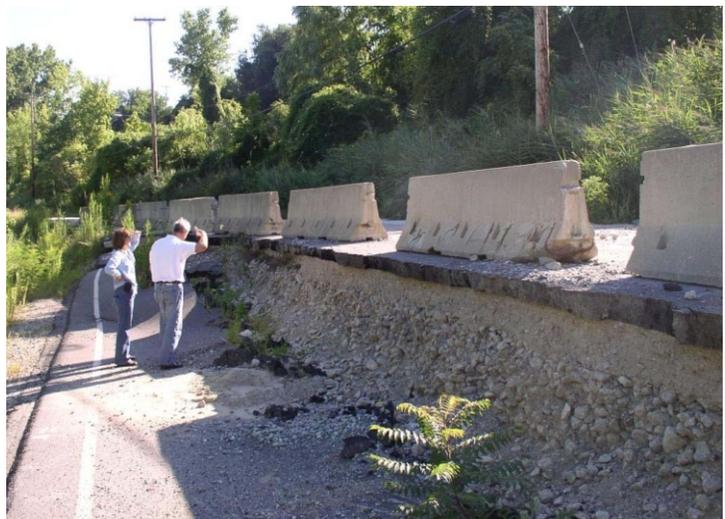
Slippage has caused fissures to open up in Riverbed Street, thus requiring its closure. This picture shows the location of the worst slippage. To restore Riverbed Street to safe use, even for such light usage as the Towpath Trail, will require a large amount of fill—fill that will be plentiful from excavation of the Scranton shipping channel.

Riverbed St., Downstream Failure.
Source: USACE Field Inspection, 20 Aug 2008

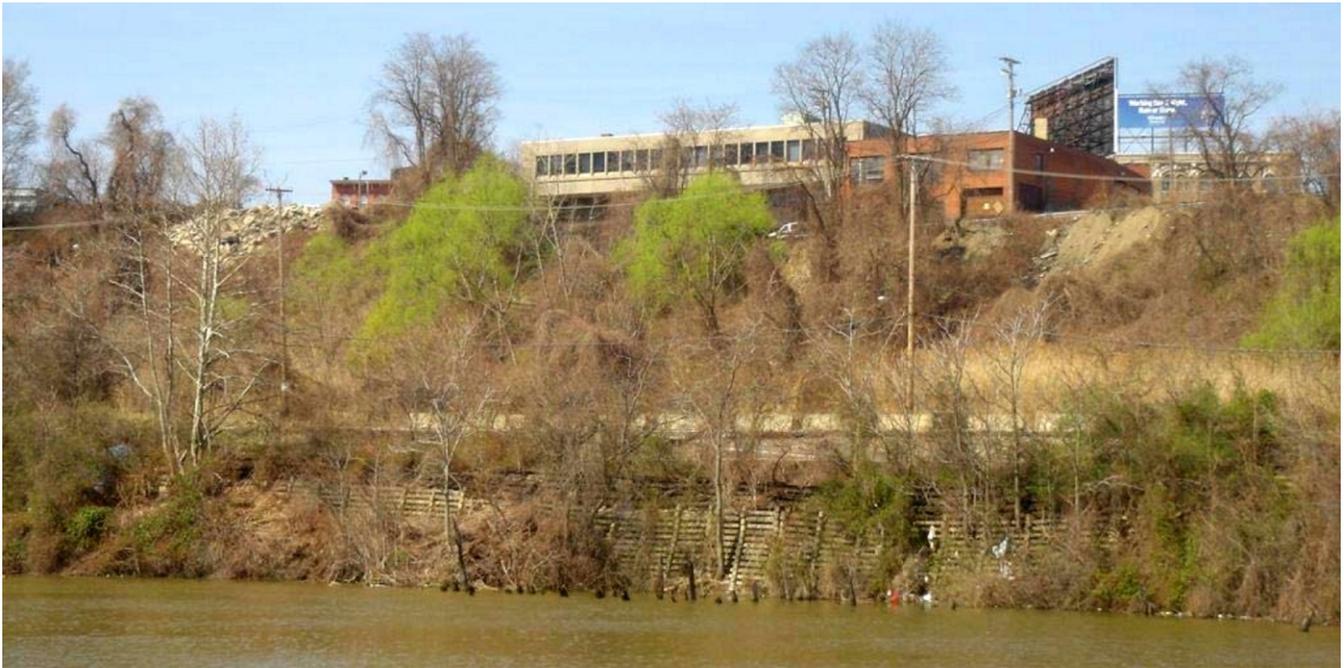
In 2008, the U. S. Army Corps photographed the west bank problems. This picture shows sagging concrete cribbing that was a failed attempt to keep back slippage. Behind it is the sagging wooden cribbing that had supported the coal trestles, and was abandoned when the coal trestles were removed. The concrete cribbing has been not only sagging, but some of the cribbing has been sinking into the river.

From Columbus Road to the Veterans Memorial Bridge, the west river bank bulkheading has deteriorated to the point of almost completely disappearing.

At the “toe” of the hillside, between Riverbed Street and the river’s edge, soil has been slipping. Parts of Riverbed Street have broken off and are sliding toward the river. Feeble attempts to stop the slippage have been futile. Concrete cribbing for stability has sagged, and some of that cribbing is now under water.

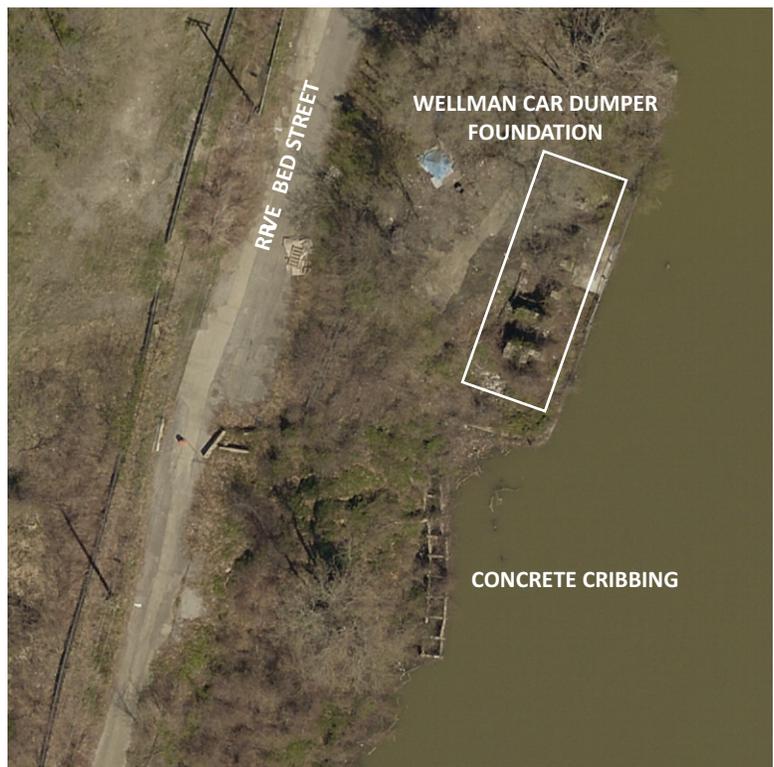
Cuyahoga County GIS image Spring 2016

Irishtown Bend Park designers have incorporated the foundation piers of the Wellman car dumper into their plans as an historical artifact, even though they didn't know much about it. Now that we know more of the history of the car dumper itself and how it was used, an educational interpretive display can be incorporated into the historic site, to make it far more meaningful than concrete piers alone.

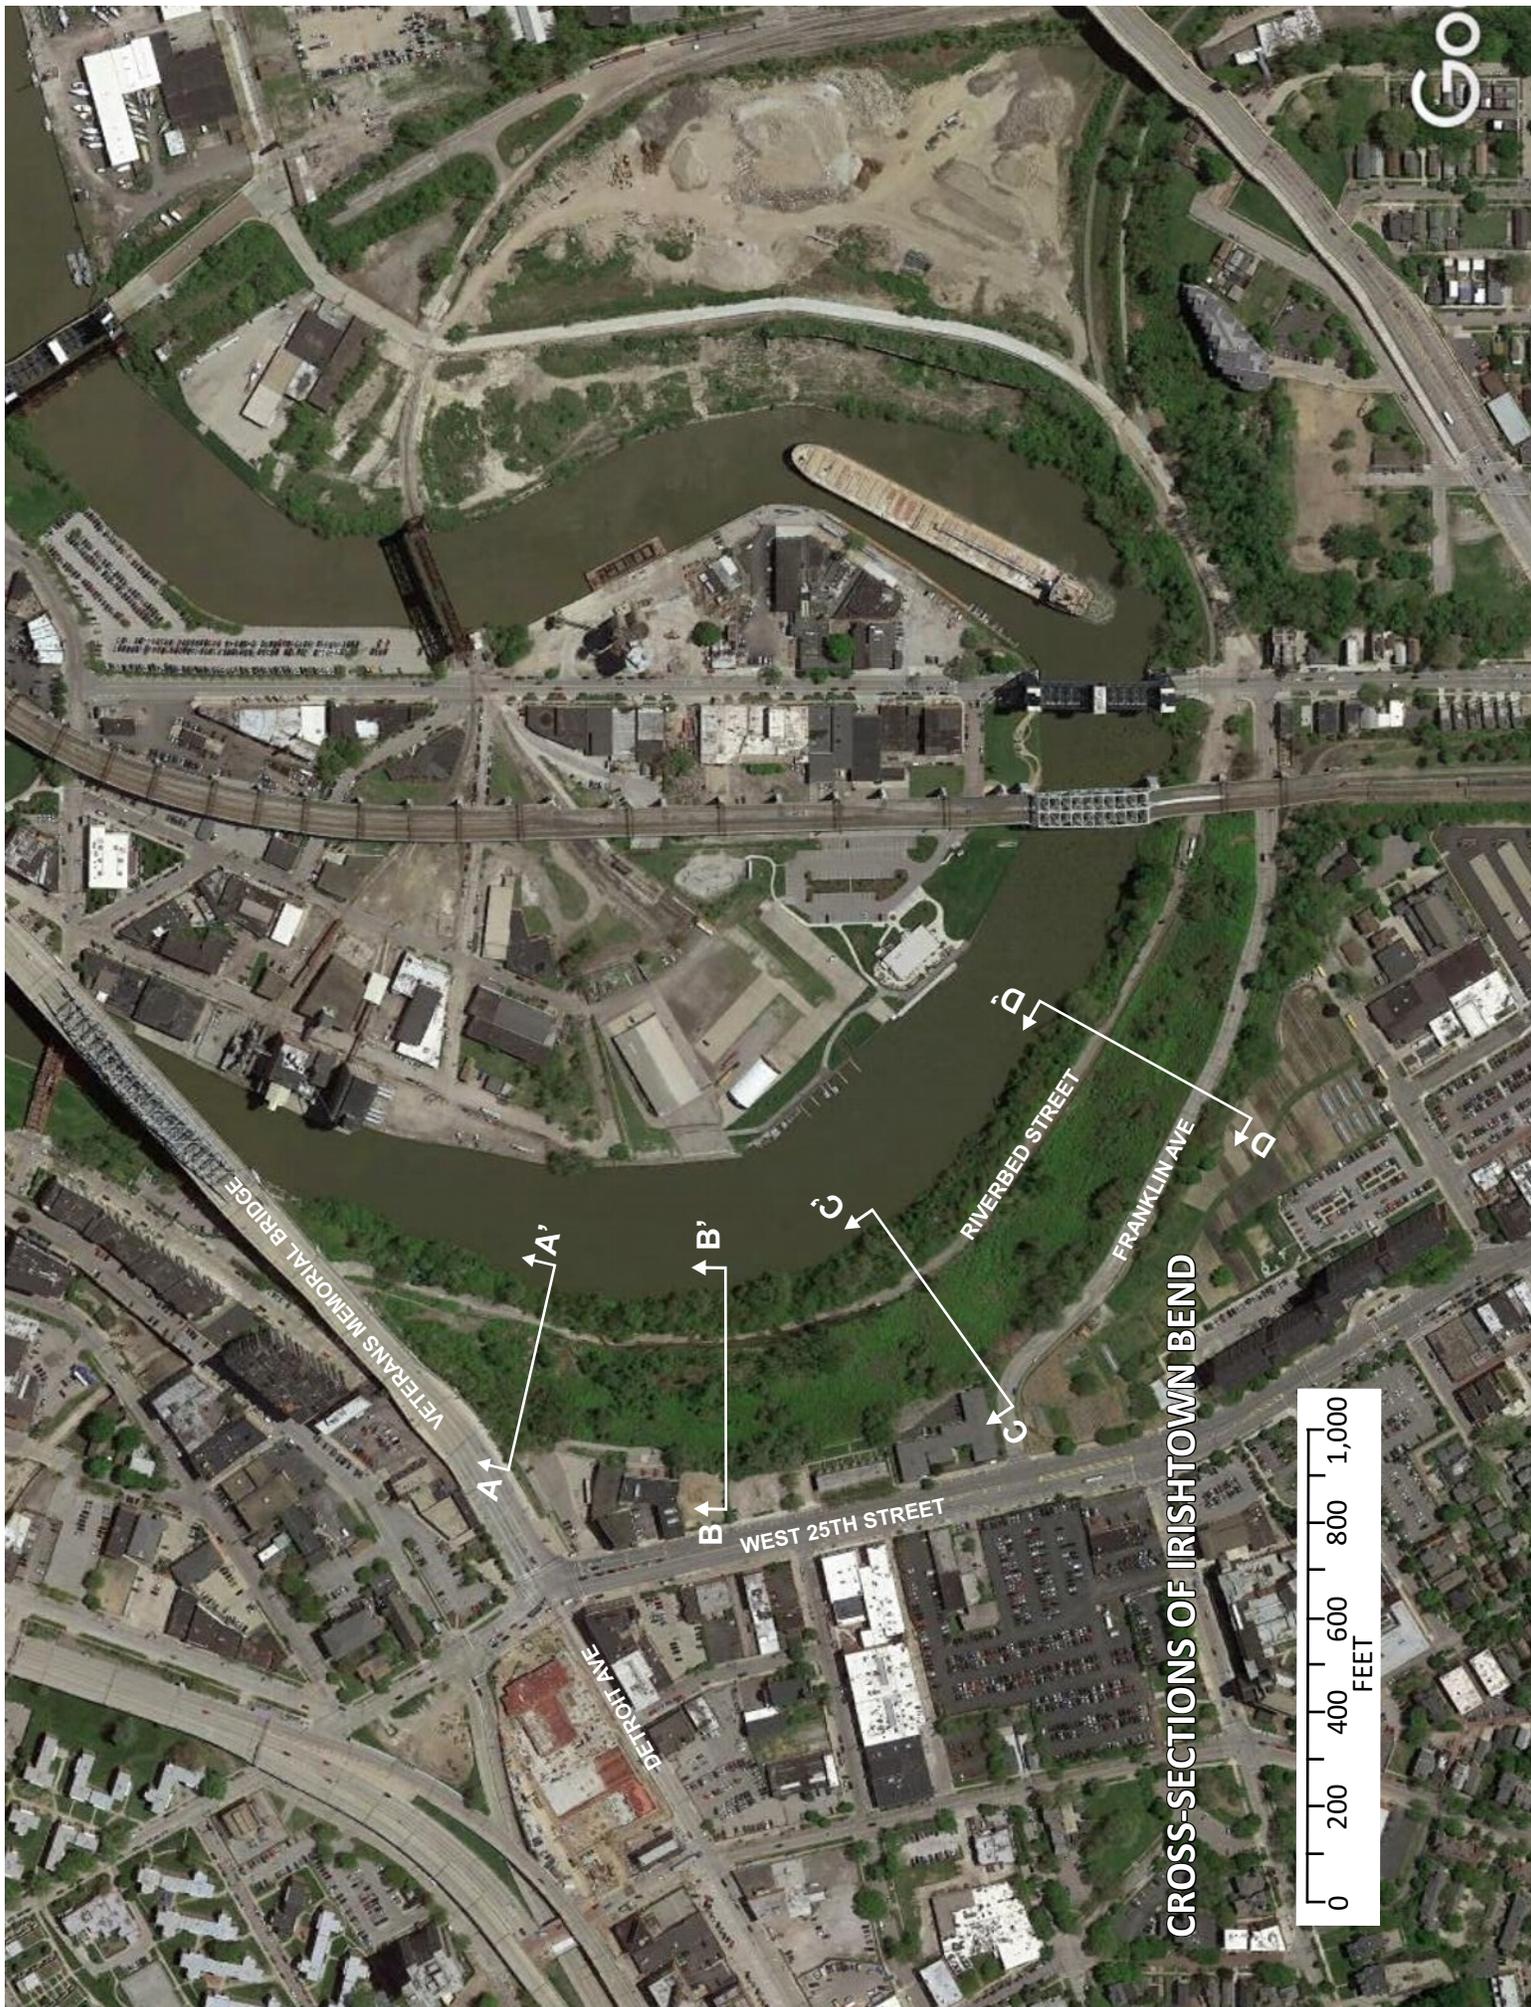
CROSS-SECTIONS OF IRISHTOWN BEND

On the following pages are a series of sections of Irishtown bend, with possible bulkheading and fill needed to maintain stability of the soil.

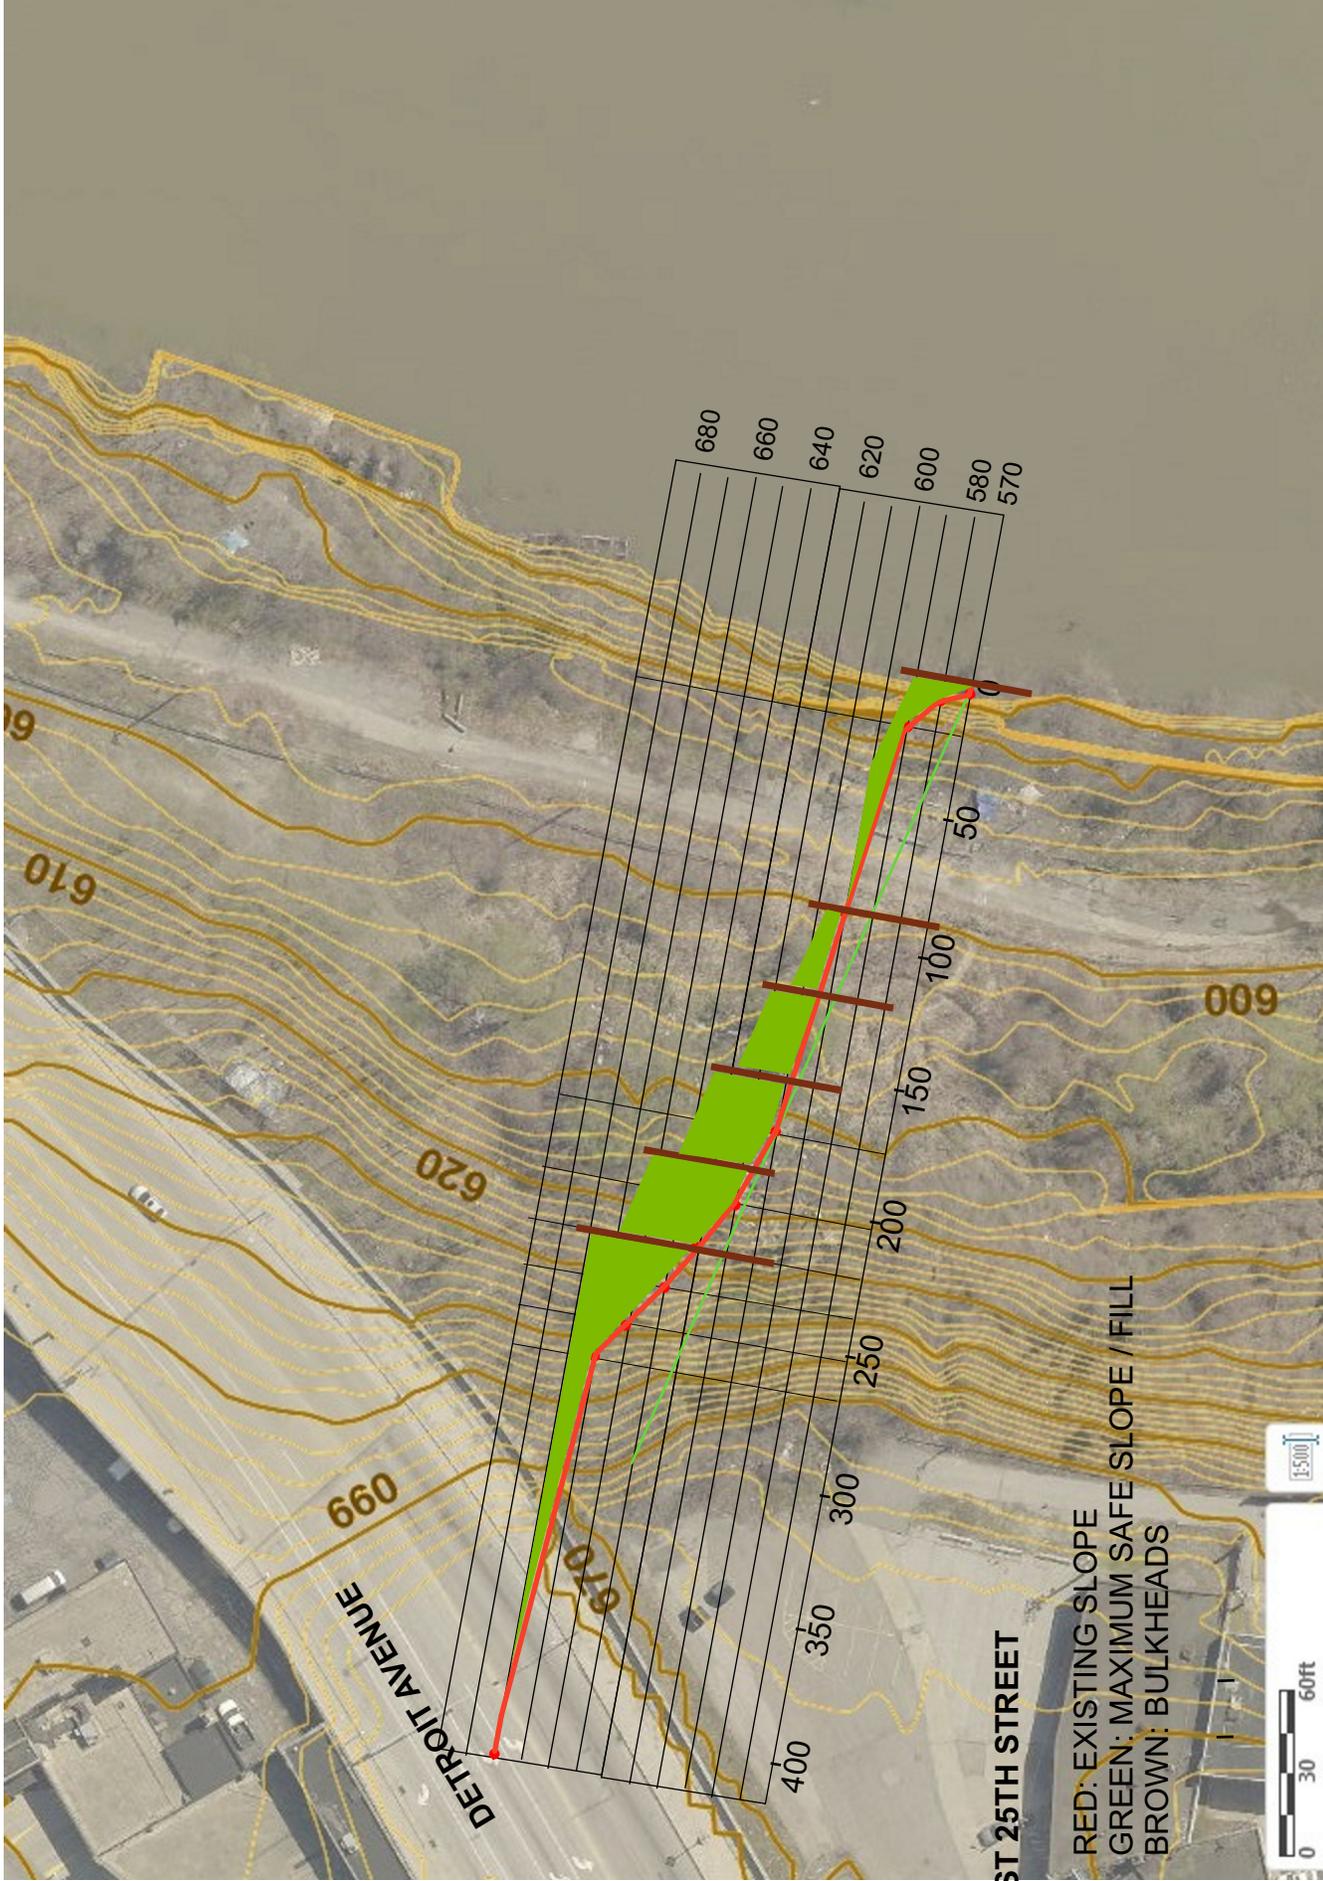
SECTION A - A'

RED: EXISTING SLOPE
 GREEN: MAXIMUM SAFE SLOPE / FILL
 BROWN: BULKHEADS

The toe of the hillside must be stabilized. New bulkheading along Irishtown Bend is a necessity. Bulkheading would most likely be sheet or box piling with tiebacks perhaps to bedrock, with fill behind the piling to stop the slippage.

The Army Corps of Engineers has determined a maximum safe slope for stability, the green dotted line. To honor that slope without destroying West 25th Street, the hill must be bulkheaded in steps. Proper bulkheading will allow development of property on the East side of West 25th Street. There is a potential for development of Irishtown bend as a public park, perhaps with zigzag terraces as a safe walking path from top to bottom. However these terraces must be bulkheaded to honor the safe maximum slope for the soil—which is not well-consolidated, but a mixture of silt, sand, and clay. (See the Army Corps report for details.)

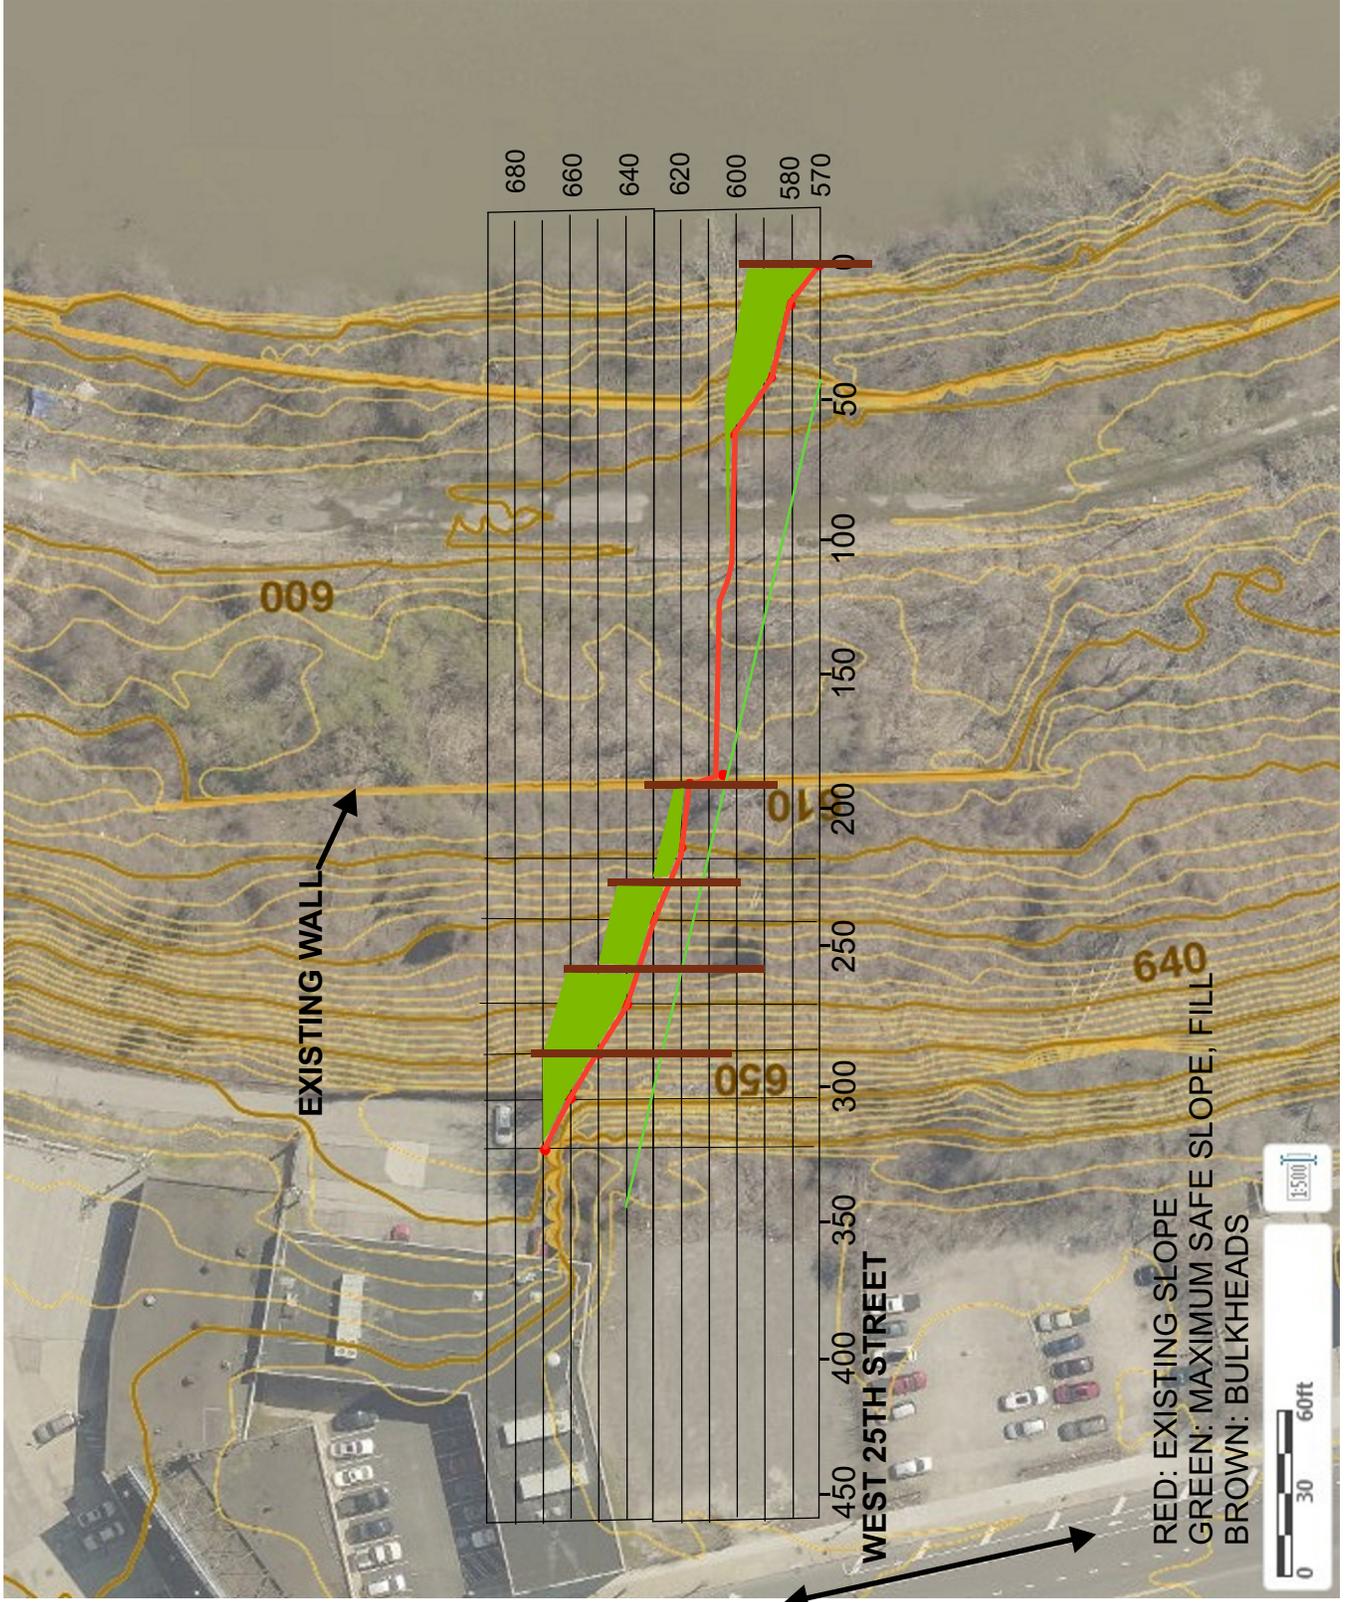
SECTION B - B'

RED: EXISTING SLOPE
 GREEN: MAXIMUM SAFE SLOPE, FILL
 BROWN: BULKHEADS

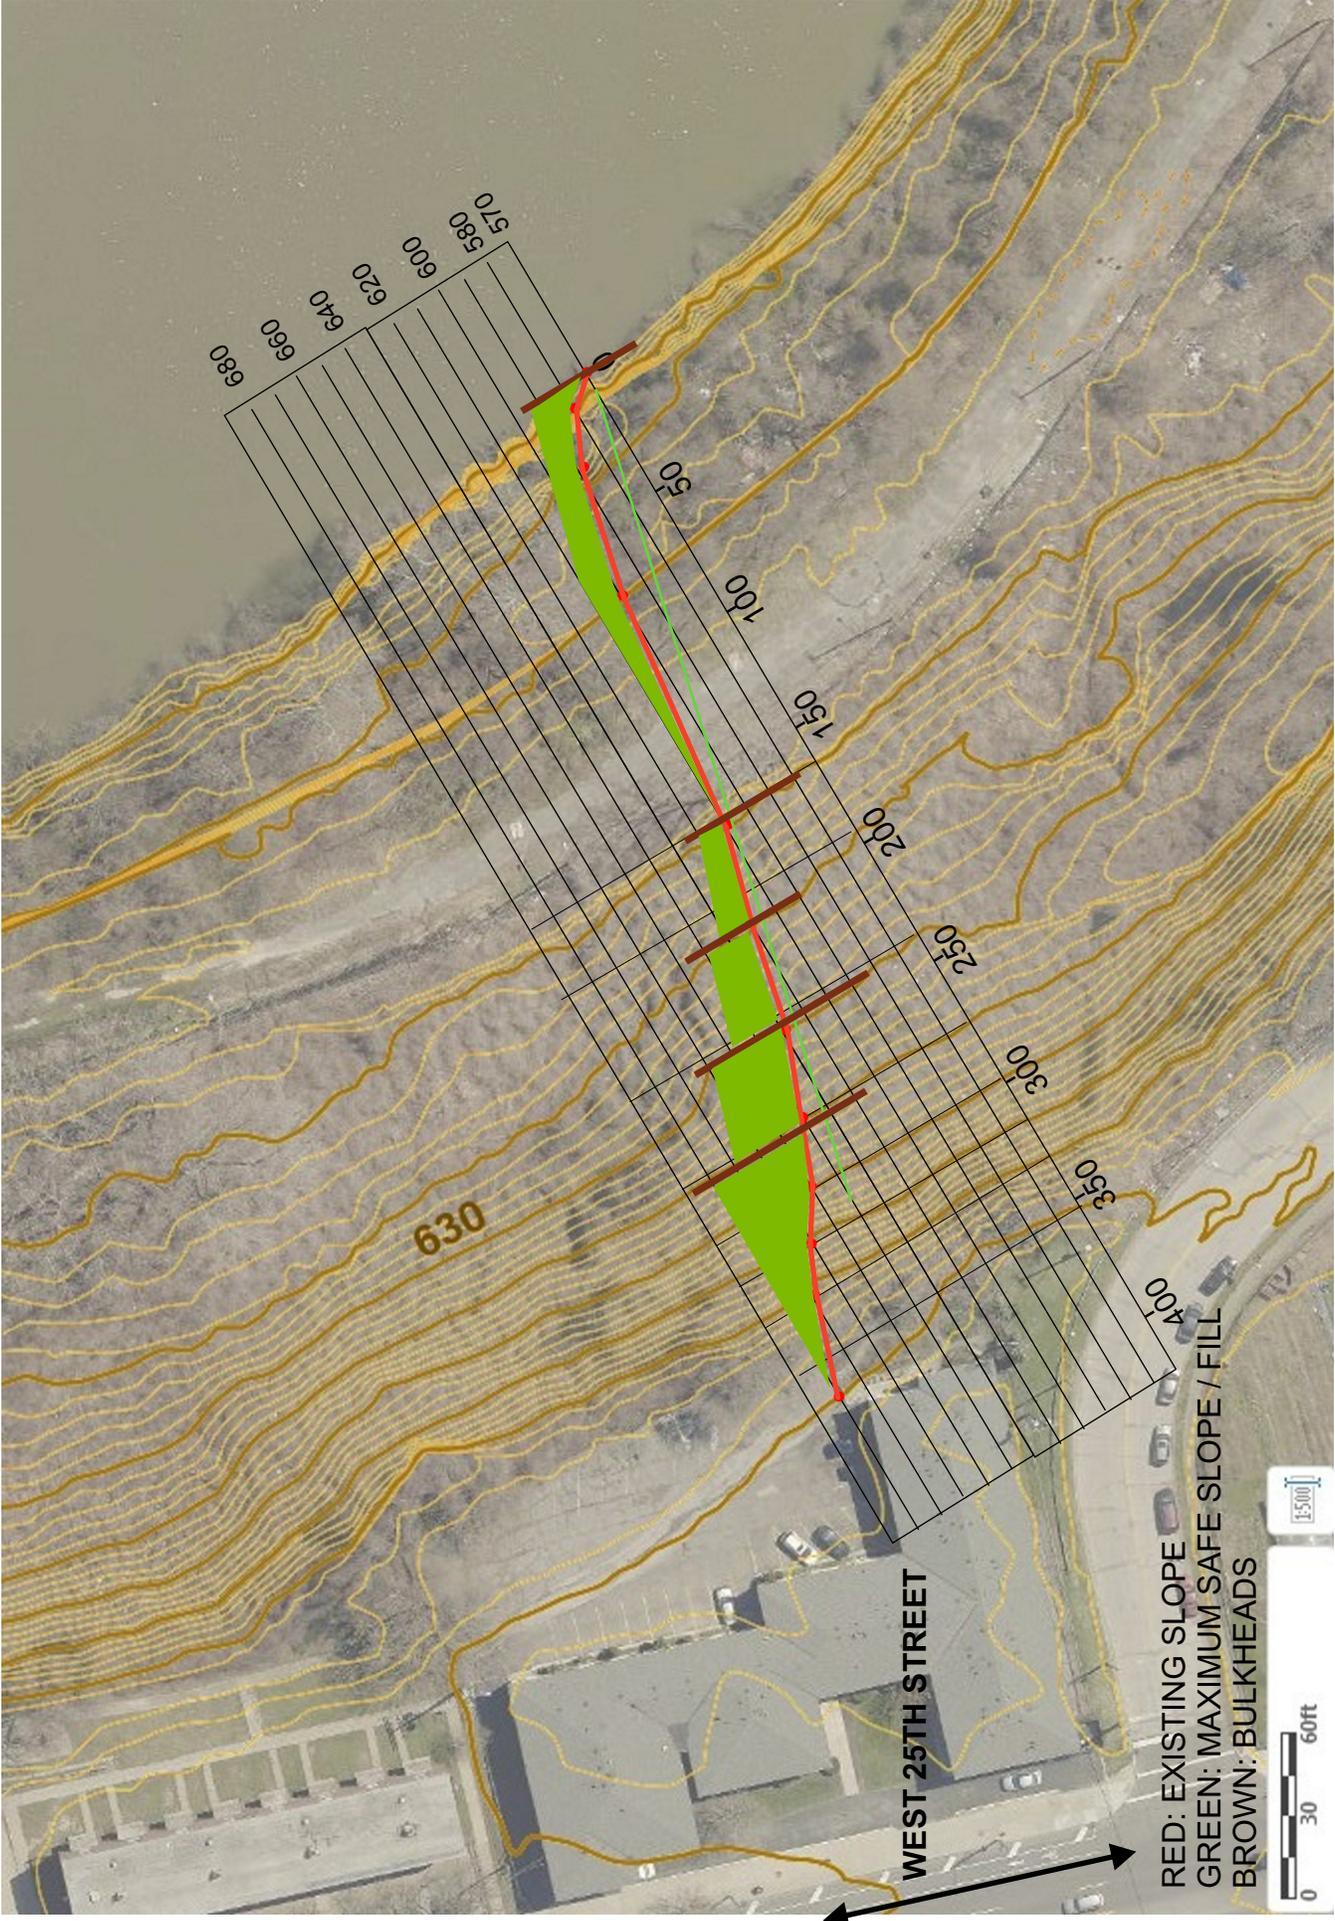
SECTION C - C'

RED: EXISTING SLOPE
 GREEN: MAXIMUM SAFE SLOPE / FILL
 BROWN: BULKHEADS
